WATER QUALITY REPORT

GJERGJI HOXHA

DECEMBER 2020

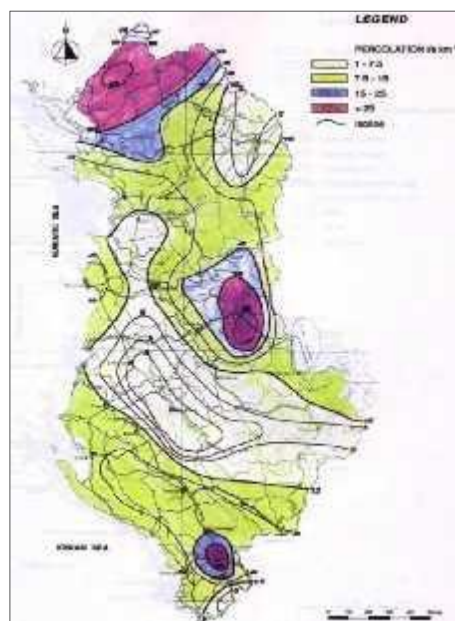
Figure 1. Map of water permeability of surface rocks

(Source: S. GURI, UNDP)
